## RAPPEL ANCHOR FAILURE | Inadequate Anchor and Backup

*Mt. Rainier National Park, Dewey Peak*

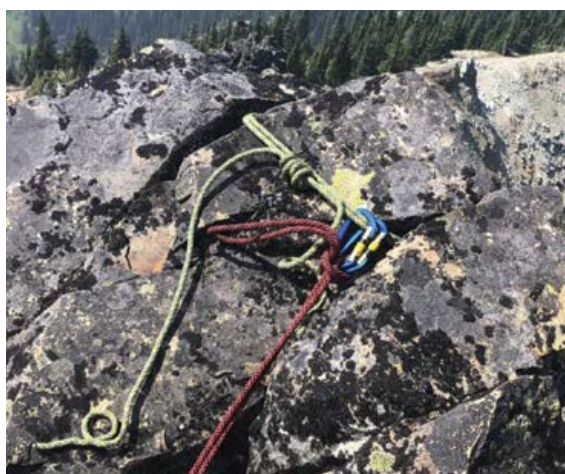
Rappel anchor that failed on Dewey Peak. An investigation concluded the yellow cordelette around the block was held in place by the carabiners linking that cord to a backup cam (not seen). When the backup gear was removed, the cordelette slipped over the block as the last rappeller started down. *Climber 3 Photo*

Tacoma Mountain Rescue and the National Park Service revisited the scene of the accident on August 25 and re-created the rappel anchors, based on photographs taken by Climber 3 before the accident and recovered from his phone. An evaluation determined that the two carabiners connecting the cordelette to the prusik sling had helped hold the cordelette in place. When the first two people to rappel loaded the cordelette with their weight, the carabiners essentially pinned the cordelette in place on top of the block. Once these carabiners were removed, the cordelette was only held in place by friction, which was insufficient to keep it from rolling and slipping off the rock.

- Not using the peak's standard rappel anchor.
- Rappelling instead of downclimbing or lowering the student climbers.
- Choosing a block anchor without a sufficient lip or horn to hold the cord securely.
- Use of cord instead of slings to build the anchor (sling material would not be as prone to rolling).
- Loosely slinging the cordelette rather than girth-hitching it around the block.
- Arranging the backup in such a way that the cordelette had to be lifted to clean the carabiners, possibly making the cordelette less secure.
- Putting an inexperienced climber in the position of cleaning the backup, evaluating if the cordelette anchor had been compromised by removing the cam and carabiners, and rappelling without a backup. (Source: Tacoma Mountain Rescue.)
